GEOTECHNICAL RECONNAISSANCE OF THE 2010 DARFIELD (NEW ZEALAND) EARTHQUAKE

Version 1: 10 November 2010

EDITORS

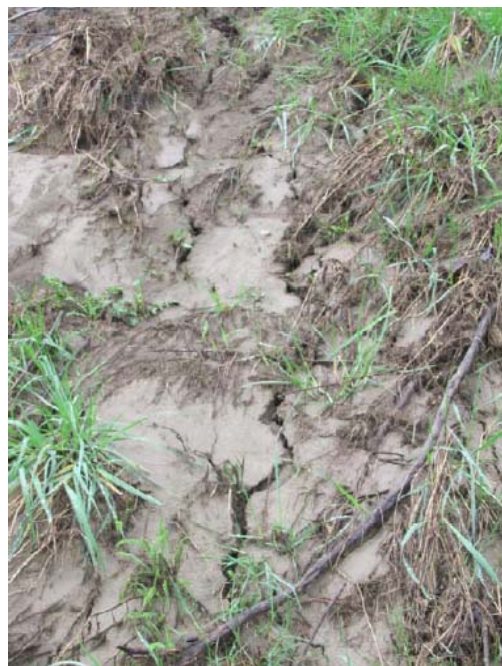
The NZ-GEER team visited the area on Monday, 13 September. On the evening of Sunday, 12 September, there had been heavy rain in the area, so on Monday the river channels were running high and the Hororata River was flowing in new areas because of a stopbank damage induced by the earthquake. The team first looked at end of Gillanders Rd. on the Darfield side, and found an area with ground damage off the end of the track, close to one of the river channels (Figure 4.37, Photo 1, BX22 257725 (43° 35' 48" S 172° 04' 48" E).

Figure 4.37 Ground damage adjacent to the bank of the Selwyn tributary near the end of Gillanders Rd (Darfield side); (Position marked as Photo 1 in Fig. 4.36)

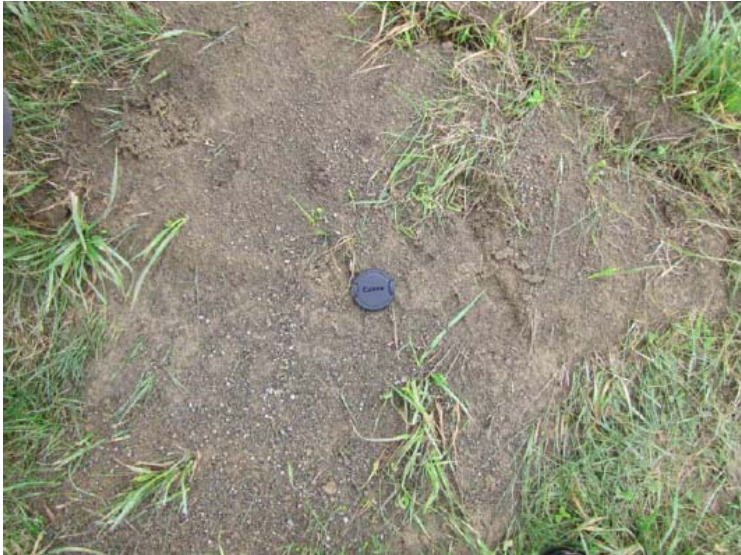
A short distance from here at the end of Gillanders Rd, the team found damage to the unsealed pavement and in the grass verge nearby. Evidence of liquefaction was seen (Figure 4.38, Photo 2, BX22 258726). Notable here was the fine gravel on the surface of the sand.

Figure 4.38 Liquefaction on the grass verge adjacent to the end of Gillanders Rd (Darfield side). Note the fine gravel particles on the surface and the fissure towards the top right hand side - it was possible to push the sampling spoon to a depth of about 300 mm into the fissure (Position marked as Photo 2 in Fig. 4.36)

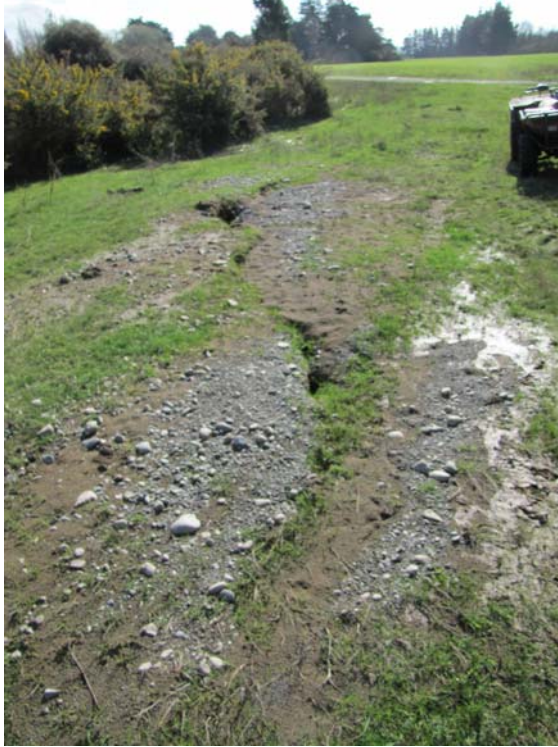
The liquefaction was located on the Selwyn Forks property (map reference BX22 250727). Access was a little difficult because a farm creek was being fed from an errant tributary of the Hororata River. The liquefaction was distributed across several fields. Material was ejected from fissures in the ground which are likely to be lateral spreads given the stream channels nearby. The ejected material was topped off with a layer of coarse gravel (Figure 4.39). Figure 4.40 shows not only sand and gravel but also clods of topsoil. It is not clear if the gravel was part of the liquefied layer or was carried to the surface with the ejected sand. When questioned, Mr Ridgen suggested that the ground profile consisted of topsoil, gravel and then sand. If this profile is confirmed then the gravel is probably carried to the surface by the liquefied sand coming from below.

Figure 4.39 Material ejected from a fissure on the Selwyn Forks farm (front paddock). Note the gravel overlying the brown coloured sand. This is what was visible after a night of rain. (Position marked as Photo 3 in Fig. 4.36.)

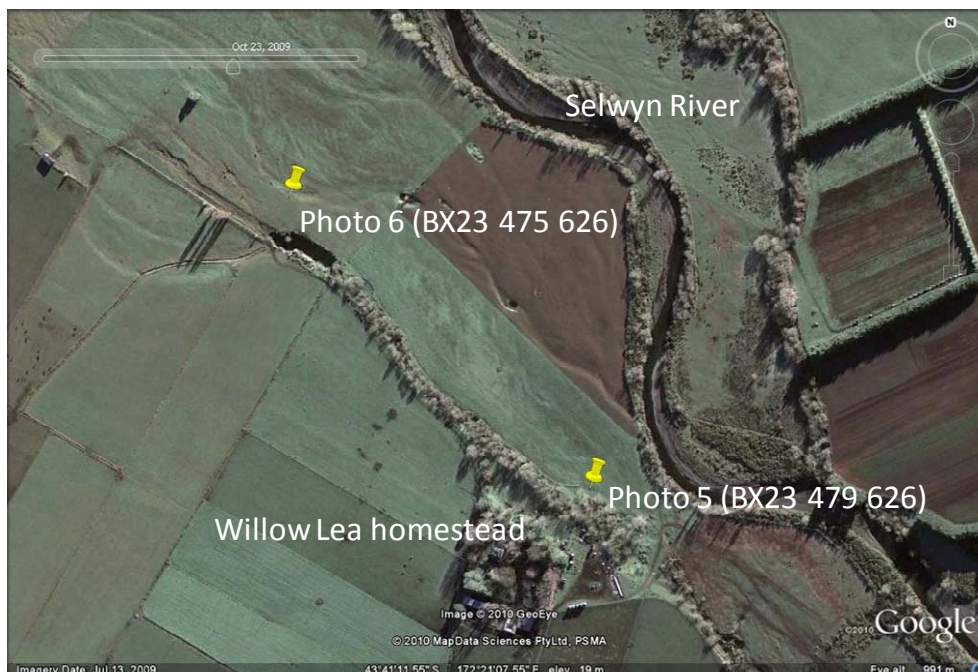
Further liquefaction adjacent to the Selwyn River, not far from the town of Leeston, was evident of the Willow Lea property near Irwell (Figure 4.41).

Figure 4.41 Location of the liquefaction along the Selwyn River in the Irwell region. (Date of Google image July 13, 2009)

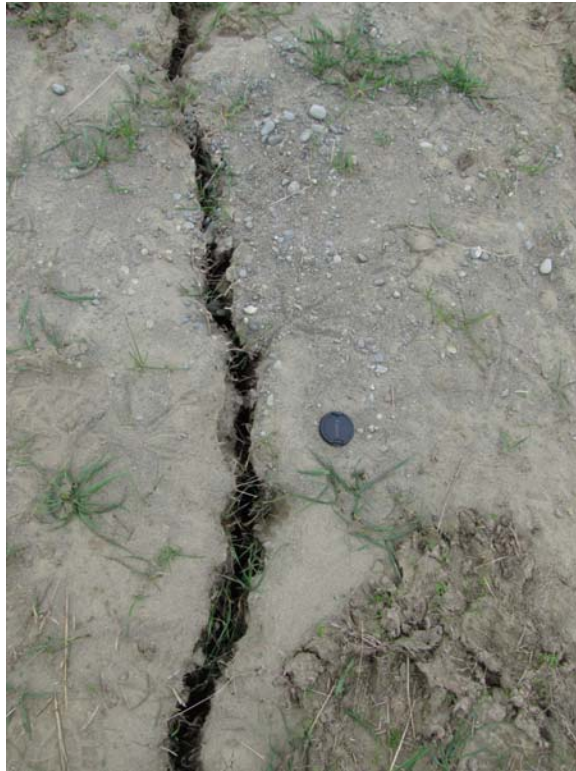
Figure 4.42 shows the material ejected at the position labeled Photo 5 (Figure 4.41, Lincoln BX23 479 626 (43° 41' 17" S 172° 21' 12" E) illustrating that the material ejected consisted of sand with some gravel. Comparison of photos in Figures 4.39, 4.40 and 4.42, shows that the materials ejected at Selwyn Forks and at Willow Lea were similar.

The farmer at Willow Lea, Mr Mark Fleming, reported that the fissures he observed were at least 2 m deep based on probing with a length of number 8 fencing wire. He also explained that the width of the fissures had increased gradually since the earthquake and that the prominence of the ejected sand had decreased with time (the photograph in Figure 4.42 was taken on September 29). More instances of liquefaction have been reported on other properties further down the Selwyn River, but the team has not confirmed this by site visits.

Figure 4.42 Ejected sand and gravel at the Willow Lea property (position marked as Photo 5 in Fig. 4.41)

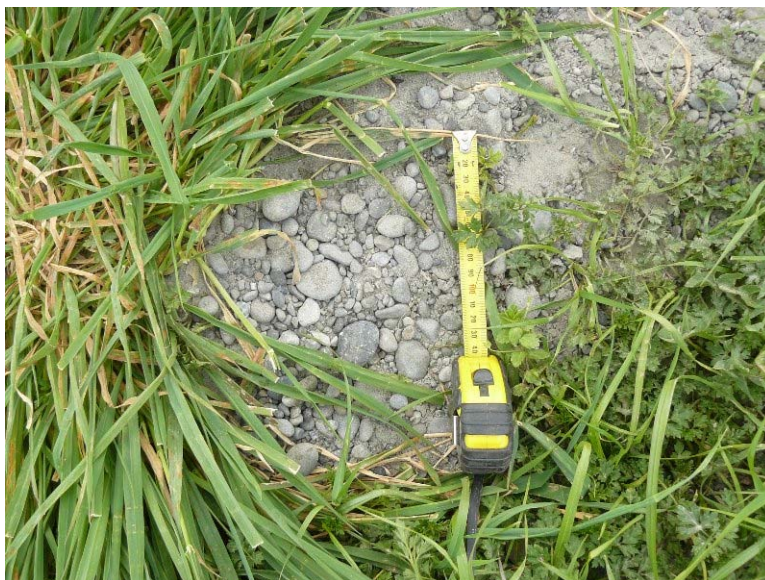
Liquefaction also occurred near the Clearwater development along Johns Road (43° 27' 15.96" S and 172° 35' 42.89" E). Figure 4.43 shows that gravel was ejected in addition to sand. There were a number of other instances of liquefaction in the open ground adjacent to the example illustrated in Figure 4.43.

Figure 4.43 Ejected sand and gravel in the Clearwater area (photo by Ian McCahon)

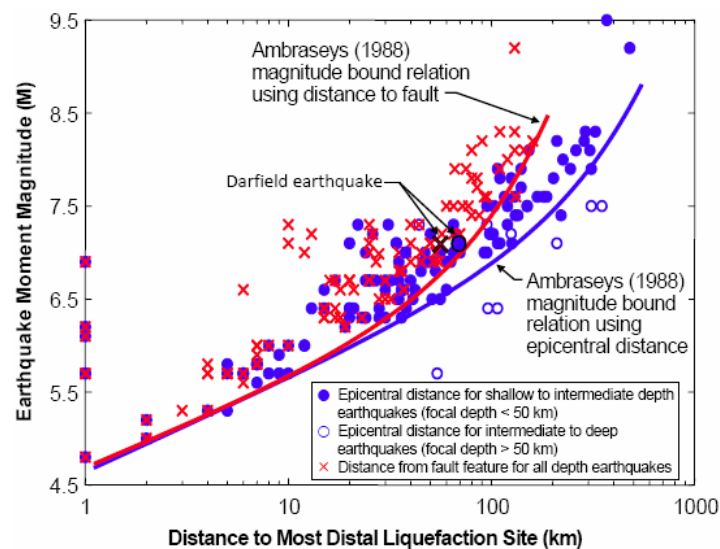
The most distal liquefaction features from the epicentre and fault rupture that the team members found or heard about are in Waikuku Beach, north of Kaiapoi along the coast, and in Akaroa, southeast of Christchurch on Banks Peninsula. The site-to-source distance to Akaroa is slightly more than to Waikuku Beach. The epicentral distance and closest distance to the fault rupture for the Akaroa site are ~54 and 44 km, respectively. These distances are plotted in Figure 4.44, along with data from worldwide earthquakes compiled by Ambraseys (1988). As may be observed from this figure, the epicentral distance falls well within the boundary for maximum distance, but the closest distance to the fault rupture is close to the boundary formed by data from other earthquakes.

Figure 4.44. Comparison of the most distal liquefaction feature from the Darfield Earthquake with worldwide earthquake data collected by Ambraseys (1988) (Adapted from Rathje et al., 2010).

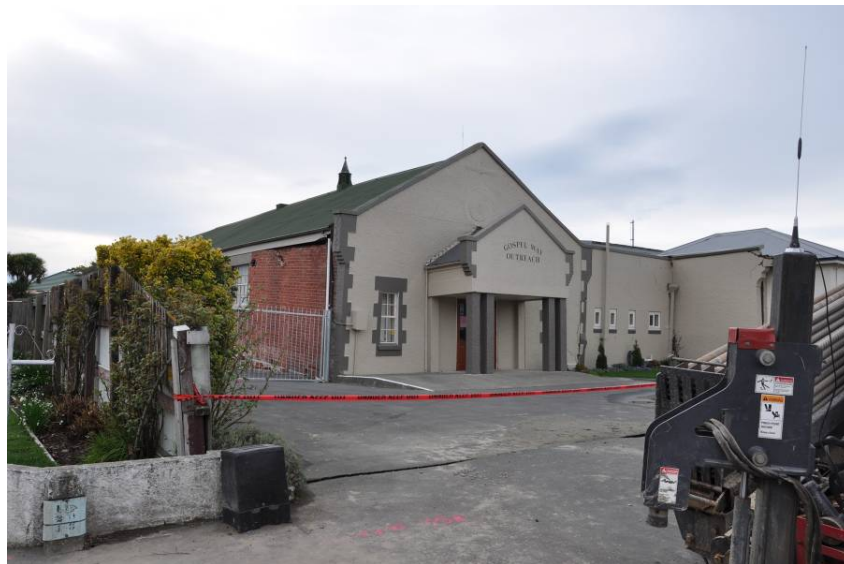
Figure 5.3 Front facing (view looking northeast) of the Gospel Way church in Kaiapoi along Charles Street. (1000 hrs on 11 September 2010)

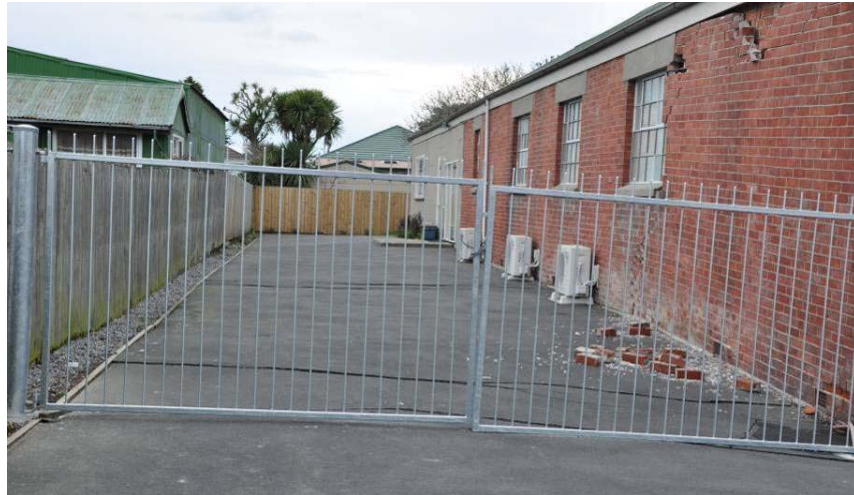
Figure 5.4 Lateral spread patterns extending east along the longitudinal axis of the Gospel Way church in Kaiapoi along Charles Street. (1000 hrs on 11 September 2010)

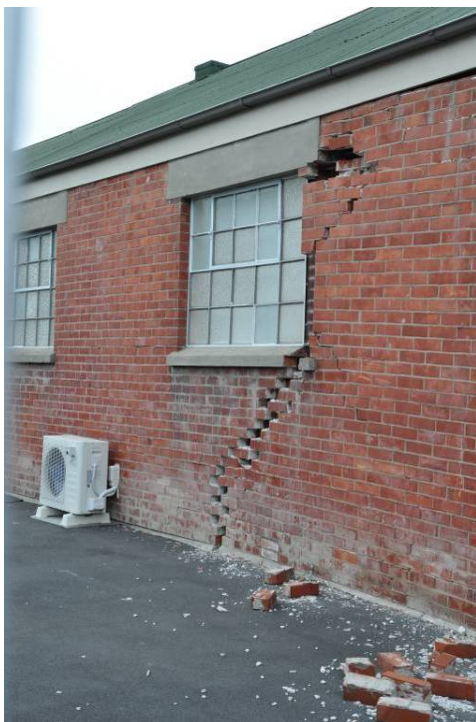
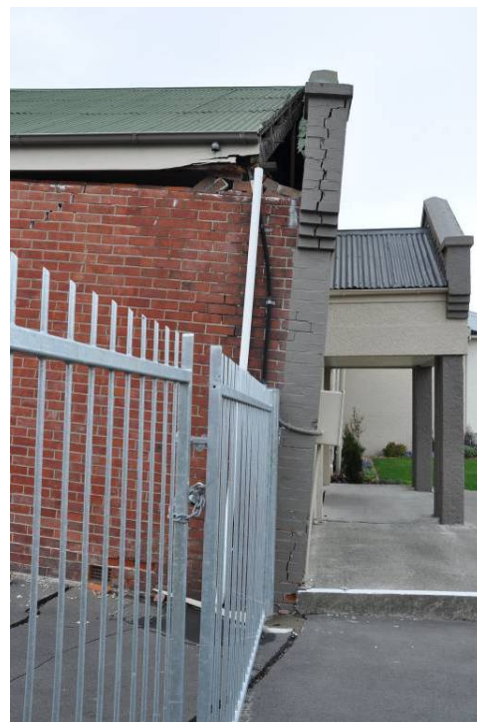
Figure 5.5 Gospel Way Church in Kaiapoi: (a) Shear crack pattern developed at brick-mortar joints along the northern side of the building and (b) separation (settlement and rotation) of the west face of the building. (1000 hrs on 11 September 2010)

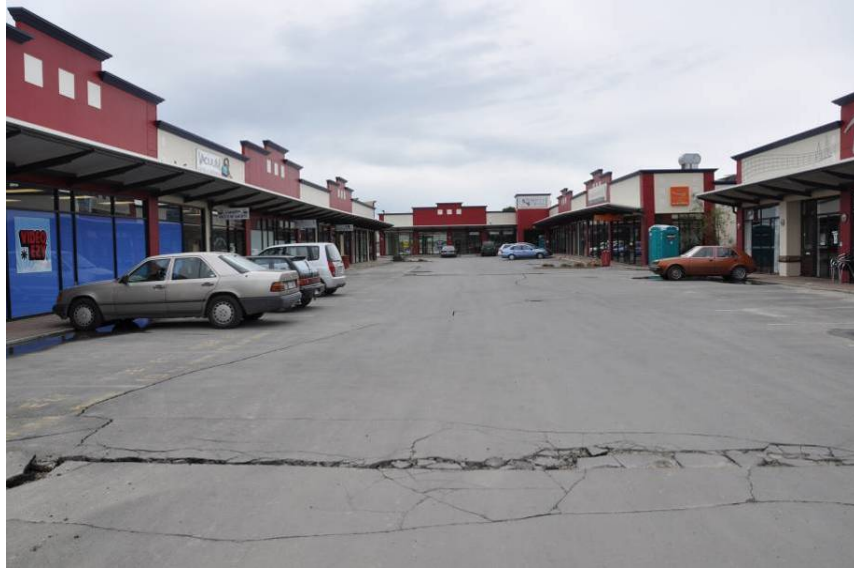
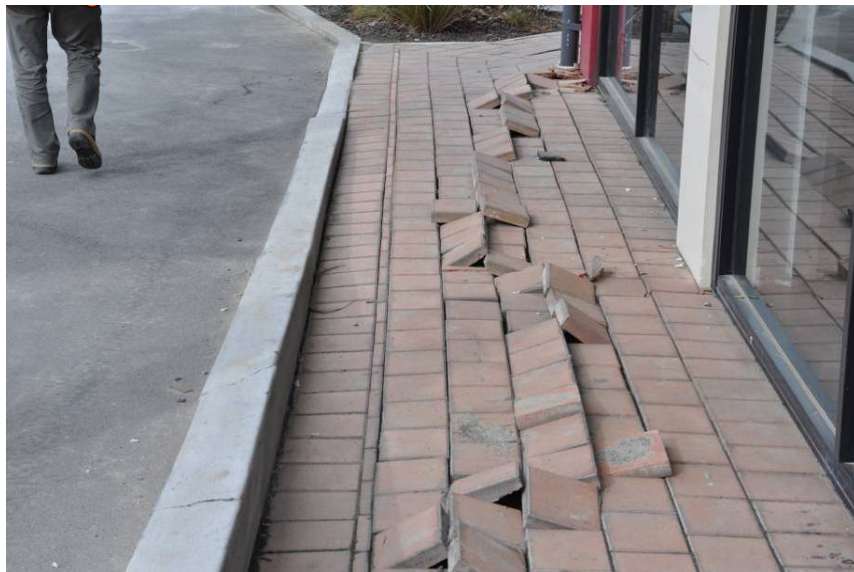
Figure 5.6 Small business attached units neighbouring the Small World supermarket in Kaiapoi (Charles Street). (a) View looking east showing ground damage pattern and (b) resulting hardscape damage at the front of one business unit. (1045 hrs on 11 September 2010)

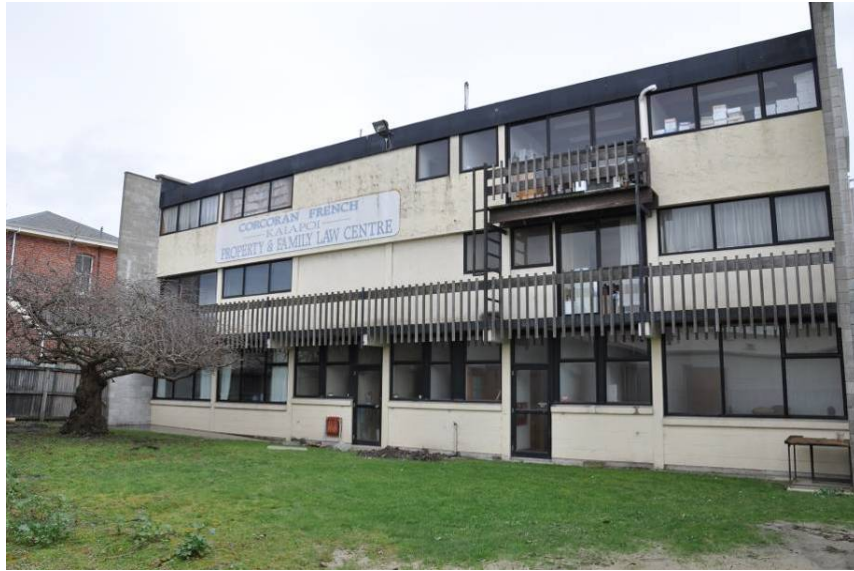
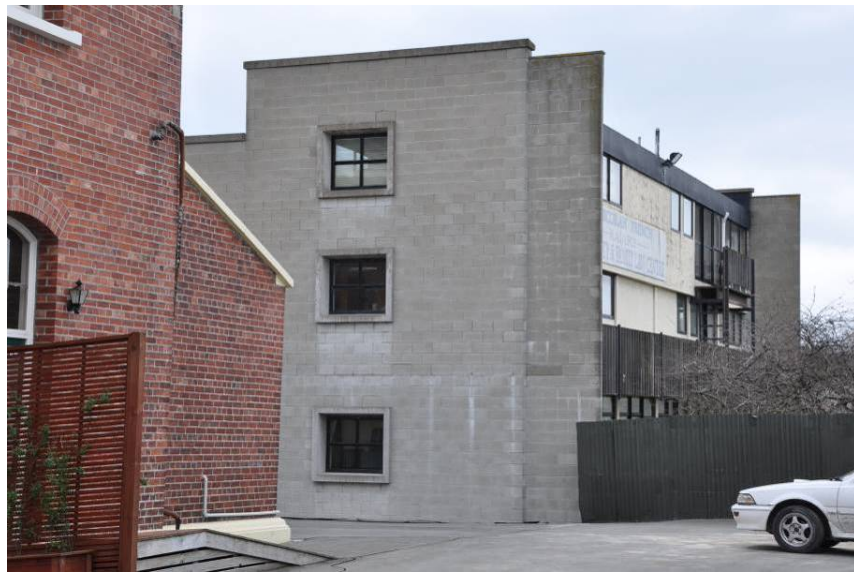
Figure 5.7 Property and Family Law Offices in Kaiapoi business district. (Williams Street)
 (a) View looking northwest (at long axis end) of building and (b) view looking northeast
 showing shearwall ends of short axis of building. (1100 hrs on 11 September 2010)

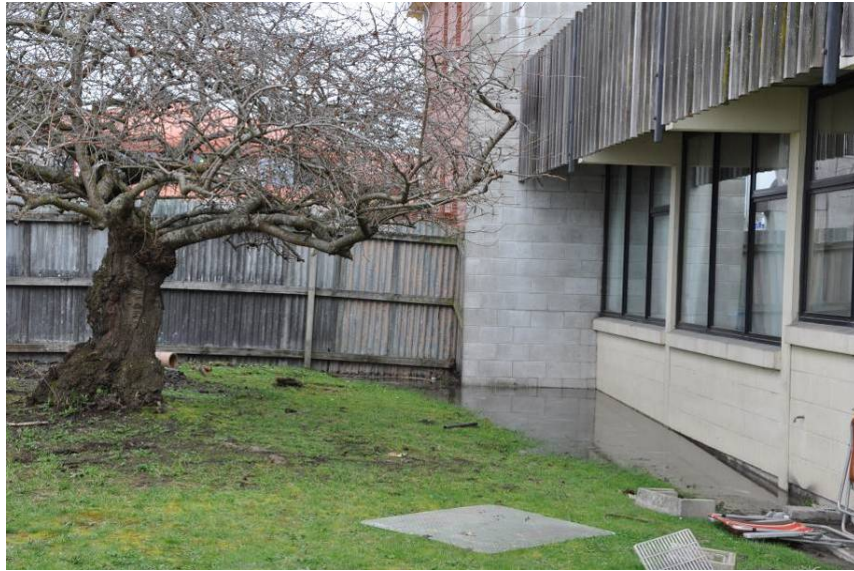
Figure 5.8 Property and Family Law Offices in Kaiapoi business district. (Williams Street). View looking at west short axis end of the building (1100 hrs on 11 September 2010)

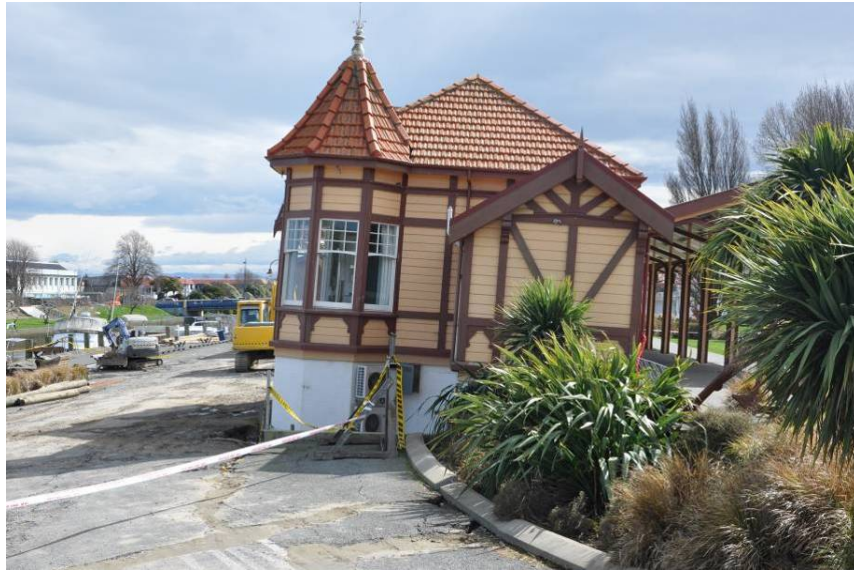
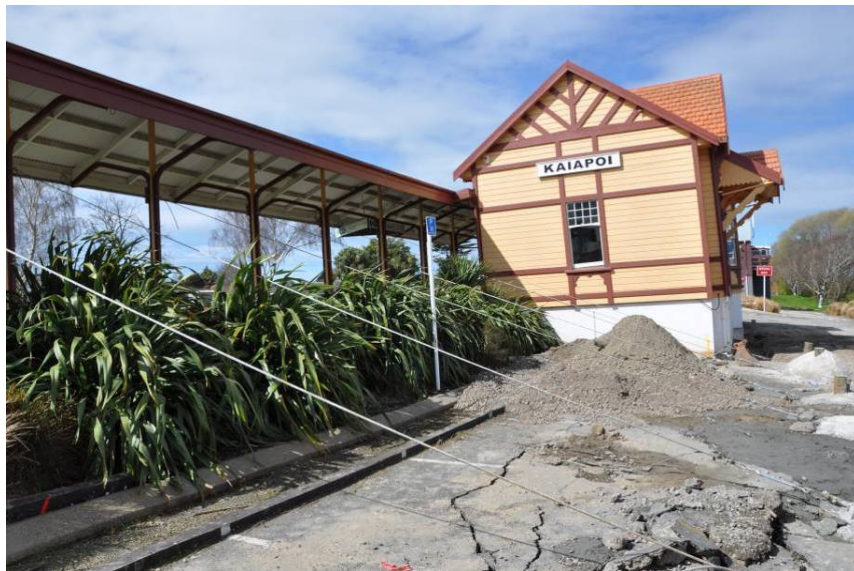
Movement of the Kaiapoi wharf resulted in damage to the historic Kaiapoi Railway Station, which is now renovated and used as the Kaiapoi Information Centre (43.3838°S, 172.6596°E) and its neighbouring Harbour Building (43.3834°S, 172.6591°E). The Kaiapoi Information Centre building is a renovated wood framed building on an elevated foundation (Figure 5.11). As a result of loss of ground support, this building tilted approximately 5 degrees northeast (away from the river). Rapid stabilization of the building had been complete by the time of the NZ-GEER team visit on 11 September 2010 in the form of concrete footings poured on the exposed (near river) foundation side of the building (Figure 5.11b). In addition, tension tie-backs anchored from newly poured concrete footings to a patio area were used to stabilize the upper pavement during the continuing ground movement. The Harbour building is a one-storey masonry block building that suffered tilting towards the river and separation from the wharf of approximately 15-25cm on its west face (Figure 5.12).

Figure 5.11 Renovated Kaiapoi Railway building now used the Kaiapoi Information Centre, adjacent to the Kaiapoi Wharf. (a) View looking northwest and (b) view looking southeast (note the temporary elevated patio support tie-backs and newly poured footings at the front (river side) of the building. (43.3838°S, 172.6596°E; 1300 hrs on 11 September 2010).

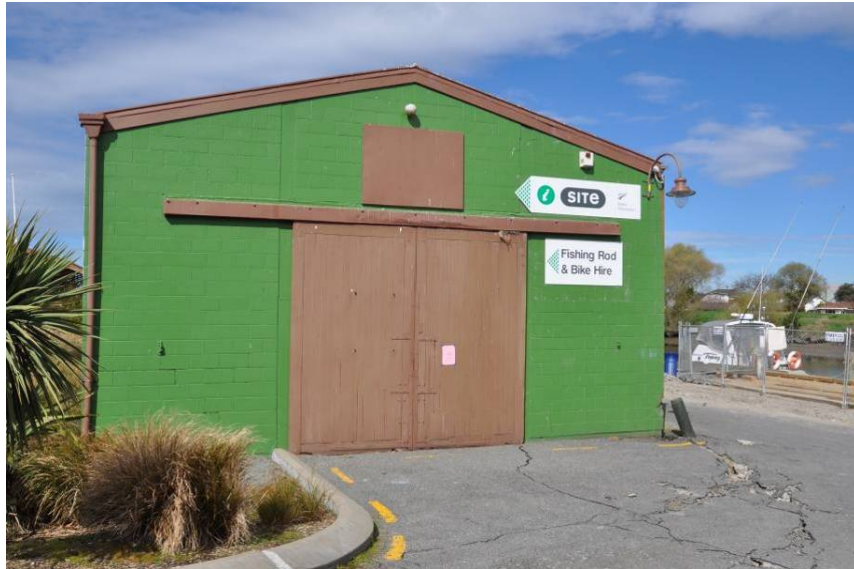
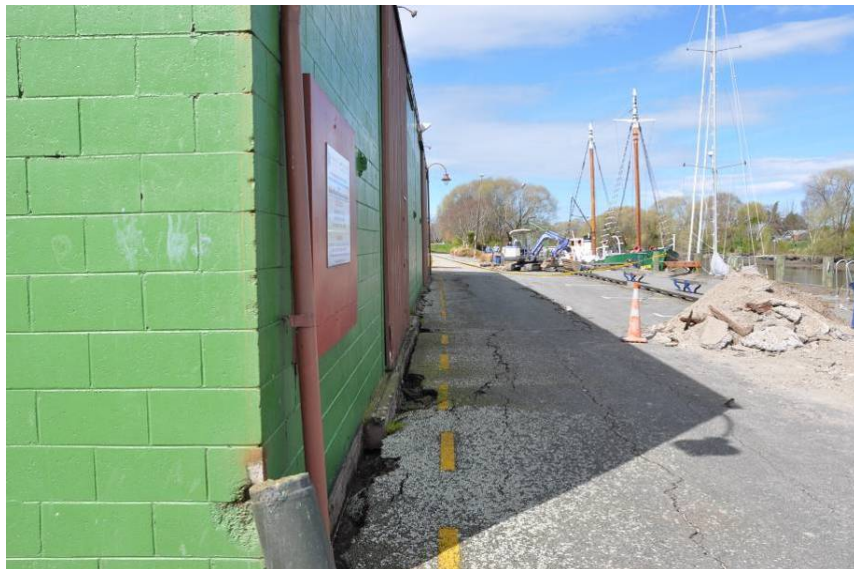
Figure 5.12 Harbour building adjacent to the Kaiapoi River and wharf structures. (a) View looking southeast and (b) view of the northwest corner of the building. Note the approximate 15-25cm gap between the pavement and building. (43.3834°S, 172.6591°E; 1345 hrs on 11 September 2010).

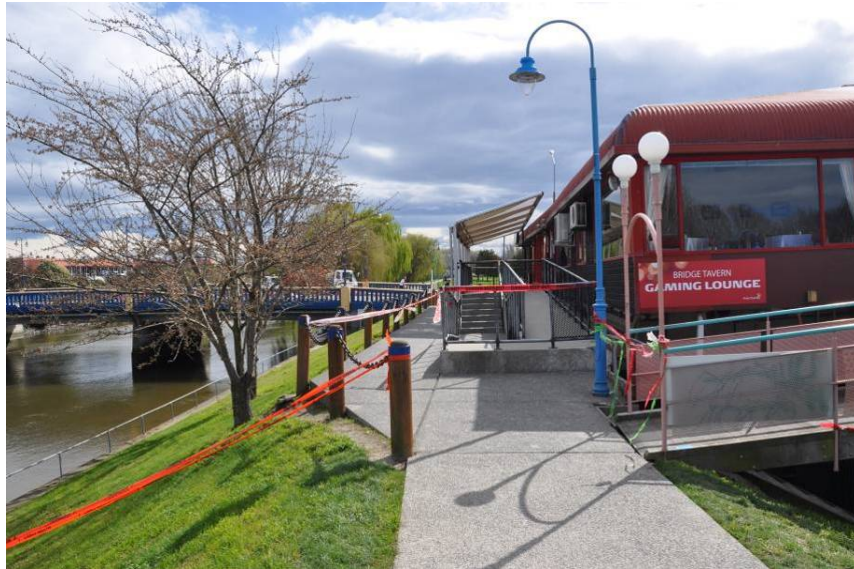
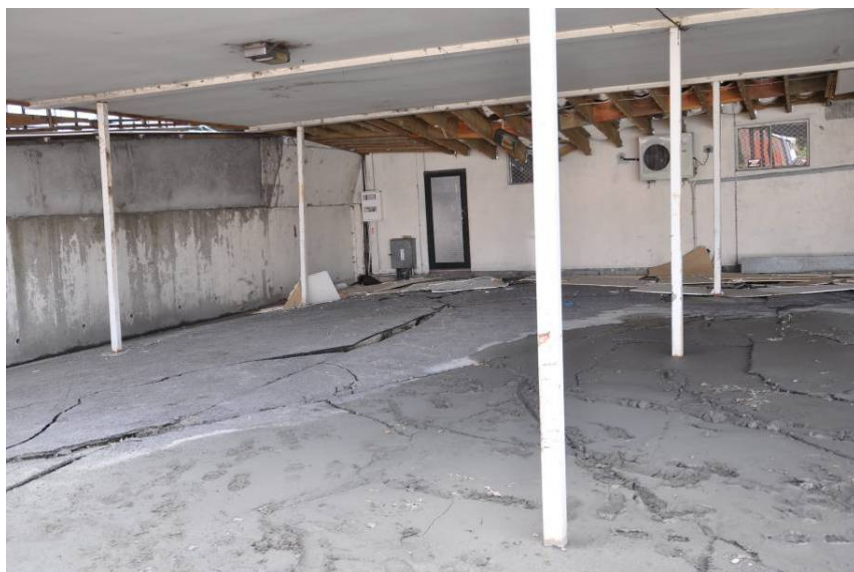
North of the Kaiapoi Information Centre and Harbour Buildings, a two storey wood frame building with subterranean parking (nearest to river) and a full floor level (nearest to Charles Street) currently housing the Bridge Tavern building was extensively damaged due to ground movement (Figure 5.13). Although movement of the retaining wall adjacent to the Kaiapoi River was not evident, the east embankment side, which supported the first storey subterranean parking area showed evidence of ground settlement and cracking. This damage precipitated movement of columns supporting the upper storey of the building (Figure 5.13b).

Figure 5.13 Bridge Tavern adjacent to the Kaiapoi River. (a) view looking northwest at Williams Street bridge and (b) view looking northwest at subterranean parking. (43.3826°S, 172.6582°E; 1345 hrs on 11 September 2010)

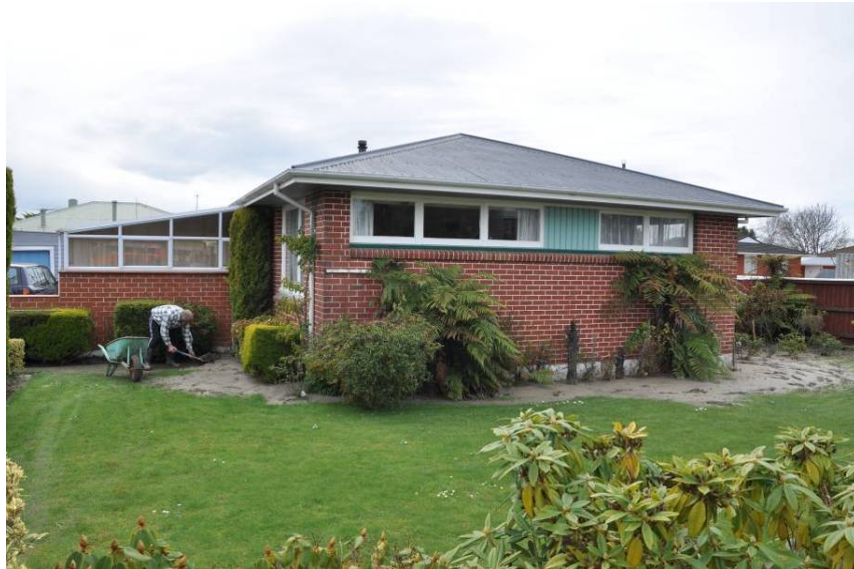
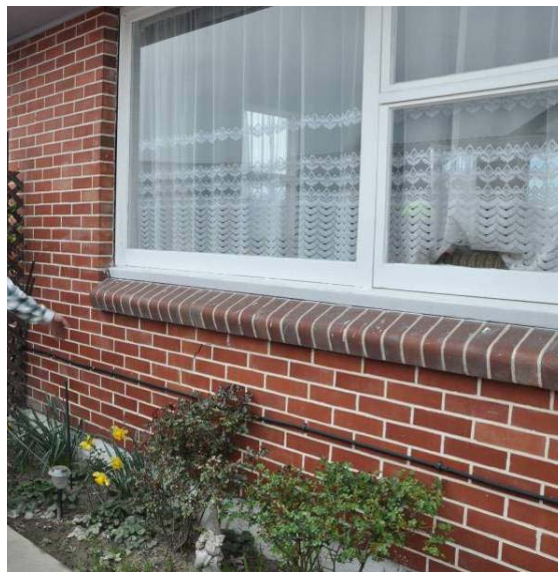
Figure 5.15 Residence along Charles Street. (a) Ejecta surrounding home and (b) shear cracking and gapping developed between window and brick due to structures movement. (1115 hrs on 11 September 2010)

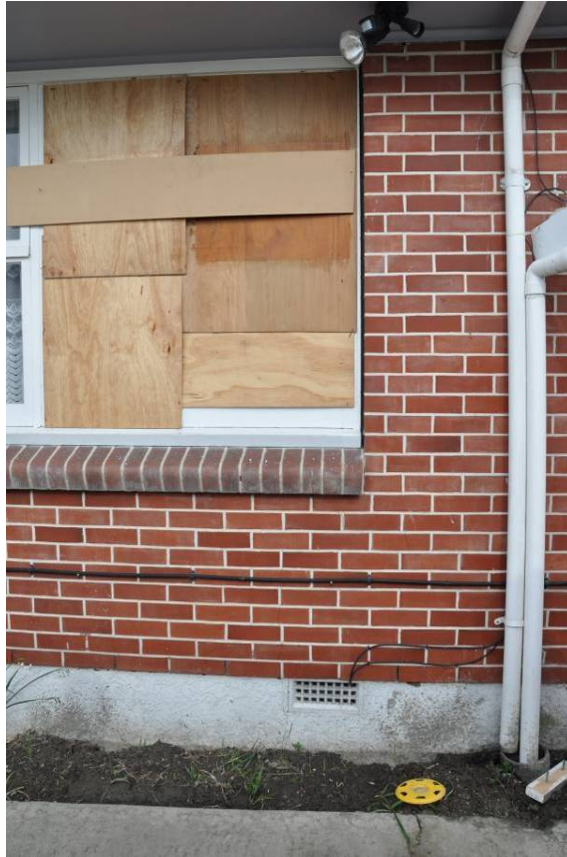
Figure 5.16 Residence along Charles Street (same structure as Figure 5.16). Damage to glass windows and between window and wall. (1115 hrs on 11 September 2010)

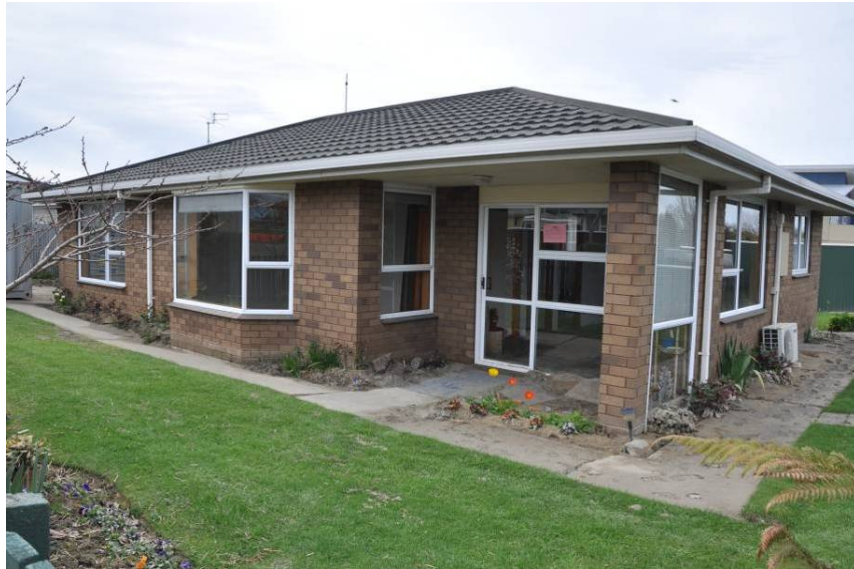
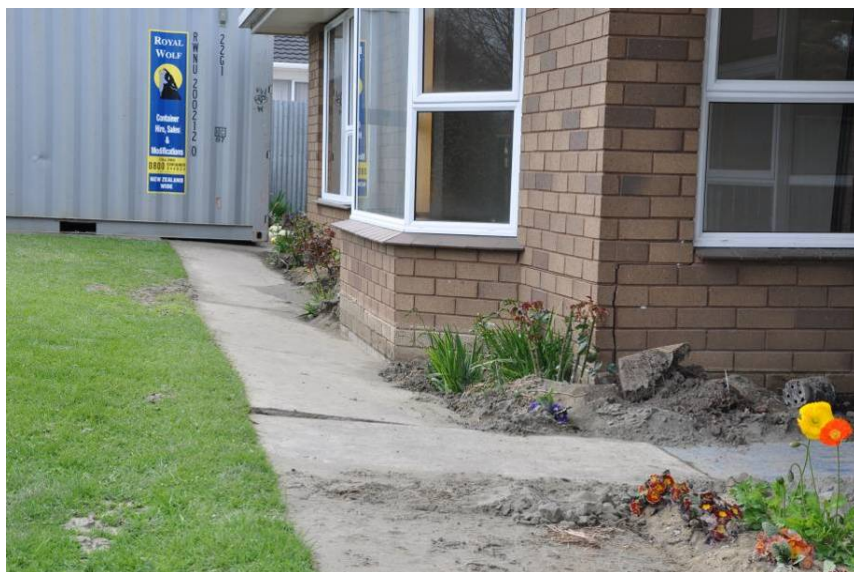
Kaiapoi North – Residential construction within the Kaiapoi North community consists of 1-2 storey wood or concrete block framed homes. A number of homes are also constructed of brick or wood with brick façade units. The vintage of these homes appeared to extend as early as 1960's construction, to more recent completely rebuilt or remodelled homes. Uniform settlement of the heavier brick constructed residential homes in this area, such as shown in Figure 5.15, were measured as large as 20-25cm. Brick homes consistently observed shear cracking, discontinuities between window and door openings and brick, popped out and/or damaged glass windows, and damage to floor slabs and hardscape (Figure 5.16). Homes along Charles Street at the time of the NZ-GEER team visit (11 September 2010) were either red or yellow tagged. Very few homes were occupied, with most suffering extensive sand ejecta surrounding the home as well as settlement. In a number of cases, residents of severely damaged homes had moved out completely (e.g. Figures 5.17-5.18). This house at Charles Street experienced approximately 0.4 m of settlement along its North face (Figure 5.17b). Sand ejecta were present surrounding most

Figure 5.17 Red tagged residence on Charles Street. (a) View looking east and (b) north end of house, view looking North-East. (1130 hrs on 11 September 2010)

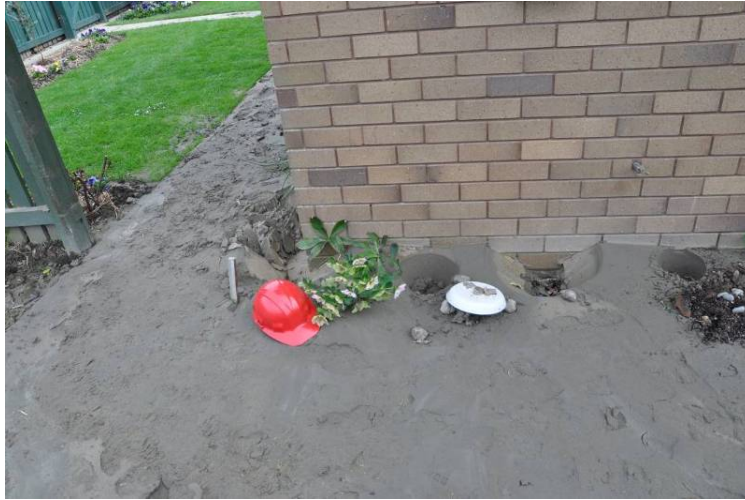
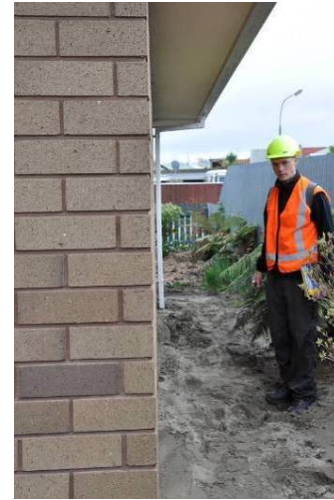
Figure 5.18 Red tagged residence on Charles Street. Extensive surrounding ejecta at perimeter of home (1130 hrs on 11 September 2010)

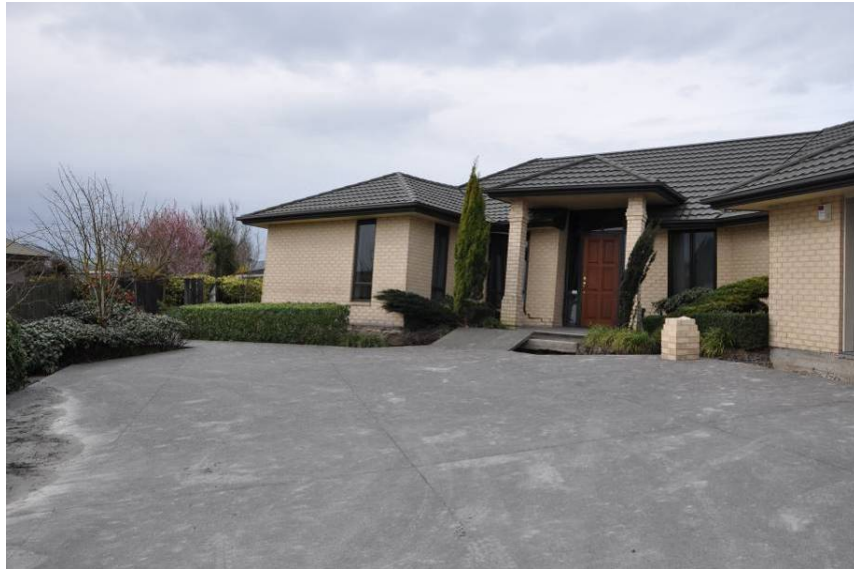
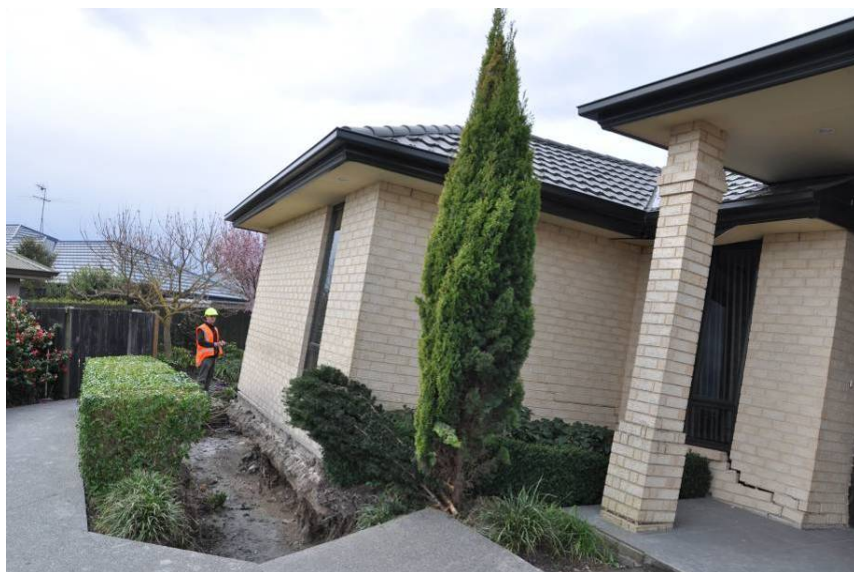
Figure 5.21 Damage to a residence at Courtenay Drive in the South Kaiapoi residential community (front of home articulating excessive tilt and separation of foundation from surrounding hardscape). (1545 hrs on 11 September 2010)

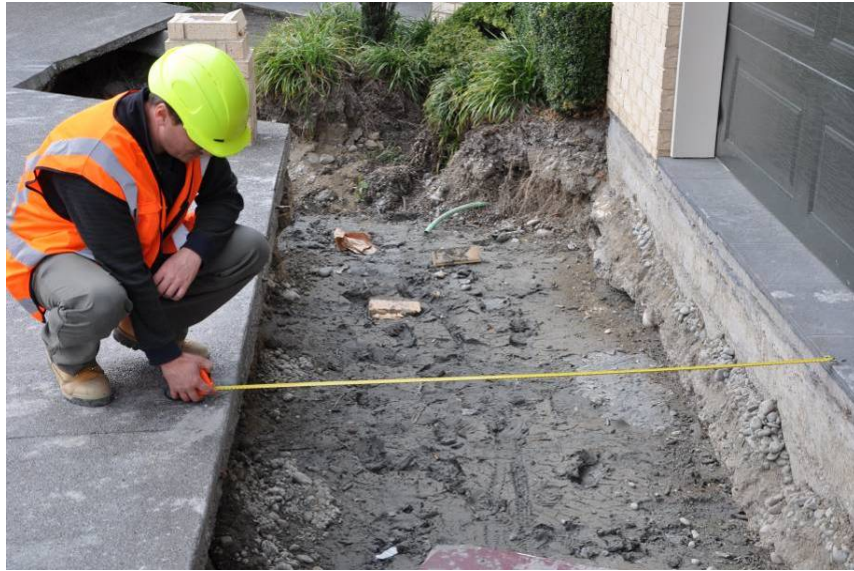
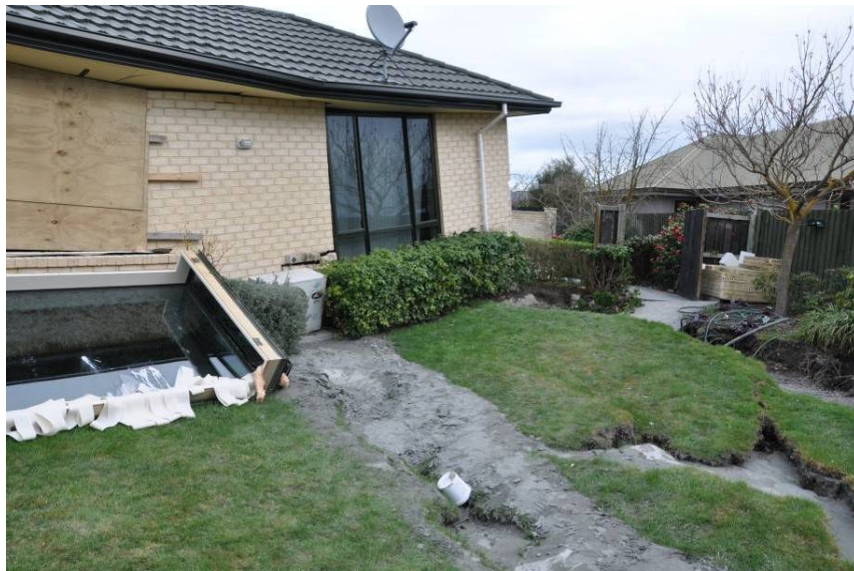
Figure 5.22 Damage to a residence at Courtenay Drive in the South Kaiapoi residential community (a) front of home (1.5 m separation between garage and approach slab) and (b) back of home. (1545 hrs on 11 September 2010)

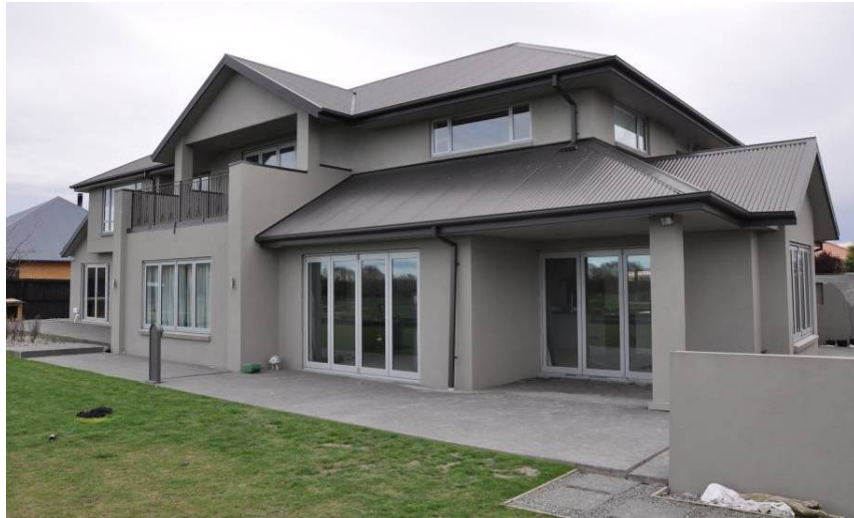
Kaiapoi South – In general damage to building structures in the Kaiapoi South community was limited to Courtenay Drive between Kaikanui Street and ending at Parish Lane. This is a residential neighbourhood with relatively new homes, all constructed within the last ten years. Most homes are one-storey light wood framing or brick supported on unreinforced slabs with perimeter stemwall foundations and light metal roofing. An example of the typical construction style in this area is shown in Figure 5.19. Liquefaction was reported to inundate the neighbourhood north of Courtenay Drive towards Charters Street, however much of this had been cleaned up by the time of the NZ-GEER team visit and appeared to have minimal impact on the homes. The impact to homes along Courtenay Drive however, and particularly those on the east side of the drive, with direct facing to a paddocks' field as well as a branch of the Courtenay Stream, was extensive. Ground failure in this region manifested in large lateral spread zones coupled with liquefaction (Figure 5.20). A manual survey by the NZ-GEER team indicated that of the 44 homes along this drive 48% suffered severe structural damage induced by ground failure, while 15 (36%) suffered moderate and minor damage, respectively. Laterally spreading ground was observed to extend through the backyards of these homes, with the lack of reinforcement within slab foundations and general light construction styles resulting in severe separation of the home directly in-line with the ground failure. The residences shown in Figures 5.21-5.24 demonstrate the observed damage due to excessive ground movement. The structure shown in Figures 5.21-5.22 suffered excessive tilting and a separation of 1.5 m from its approach driveway to the front of the home (Figure 5.22a), while the rear of the home collapsed inward due to surrounding ground fissures (Figure 5.22b). Similarly, the residence in Figures 5.23-5.24 articulated little to no damage at the backside of the home (Figure 5.23), however the front entry

Figure 5.23 Damage to a residence along Courtenay Drive in the South Kaiapoi residential community. Backside of home facing Paddocks field articulates relatively no damage (1600 hrs on 11 September 2010)

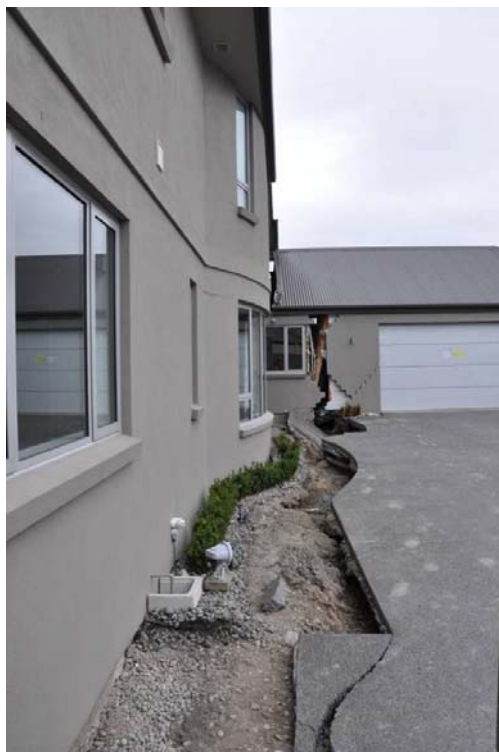
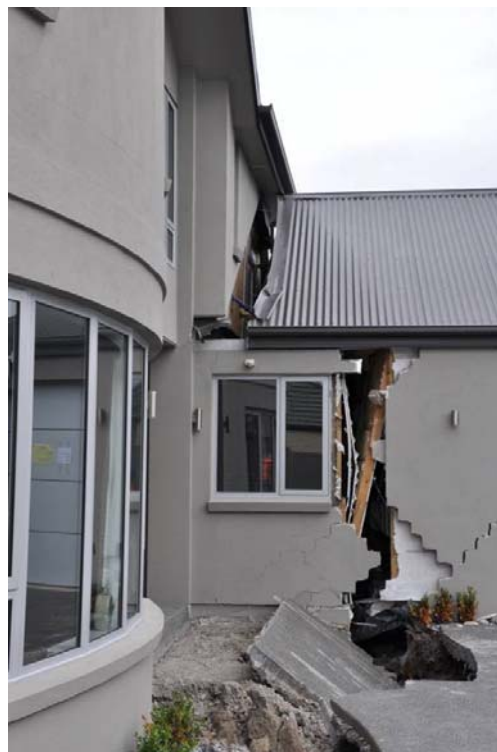
of the home at the interface between the garage and main portion of the residence suffered a separation of about 1m due to lateral ground movement (Figure 5.24).

Figure 5.24 Damage to a residence along Courtenay Drive in the South Kaiapoi residential community. Front entry articulates extensive damage as large ground spreading subtends into the superstructure. (1600 hrs on 11 September 2010)

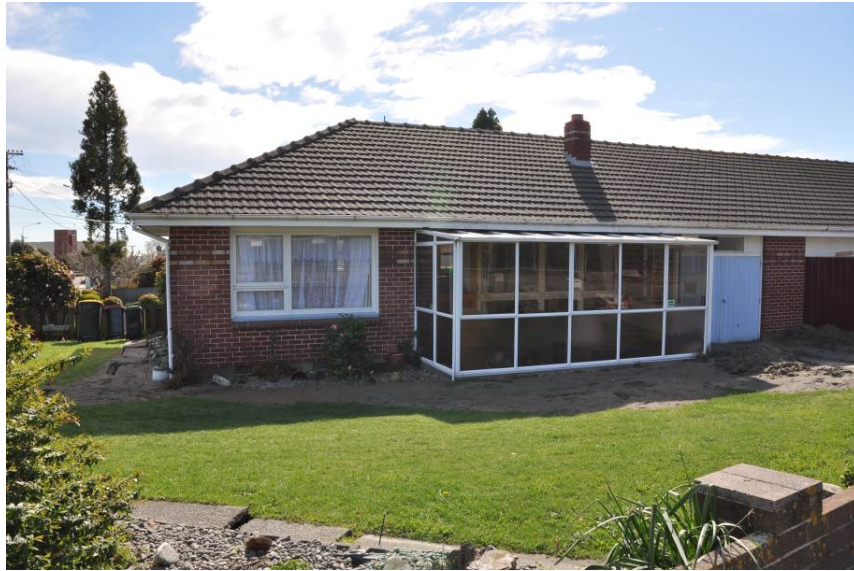
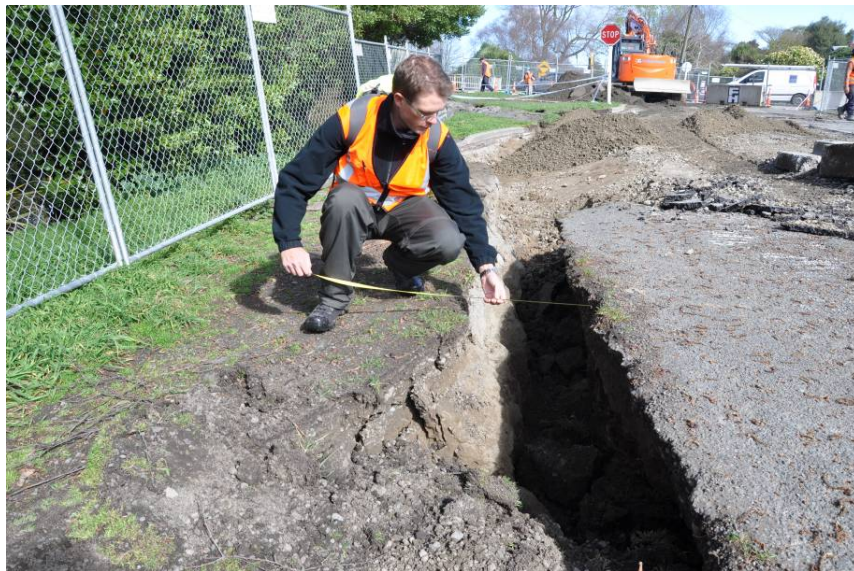
Two common types of damage to residential structures within this community are shown in Figures 5.25 and 5.26. Both of these structures are located near the Avon River. The residence shown in Figure 5.25a directly fronts the Avon River and experienced approximately 3 degrees of rigid body tilt directly south towards the river. Structurally the home was in good condition, though inspection of the interior articulated extensive floor and nonstructural damage. Lateral spreading extension features were observed at the front of the residence at the river and continued north behind this residence (Figure 5.25b). Transects taken by the NZ-GEER team on 14 September 2010 at this location indicate 85 cm of lateral extension fronted the residence, with vertical offsets in extensions as large as 19 cm and cracks extending as great as 105 cm (T7 in Figure 5.27). Figure 5.26 shows a house in Locksley Avenue, which illustrates a loss of ground support subtended along the structure length. At this location lateral spreading towards the Avon River (behind the position from which the photo was taken) is evident in the driveway. Differential settlement along the length of the house manifests itself as shear cracking and separation of the mortar-brick within the brick veneer wall. This mode of deformation is similar, but less intense, to that imposed on the slab-on-ground foundations of the houses illustrated in Figures 5.20-5.24.

Figure 5.25 (a) Rigid body rotation of a residence in Dallington (Locksley Avenue) due to liquefaction and (b) lateral spread features directly fronting the home. Surveys of ground features at this location are associated with T7 (refer to Figure 5.27). 1200 hrs on 14 September 2010

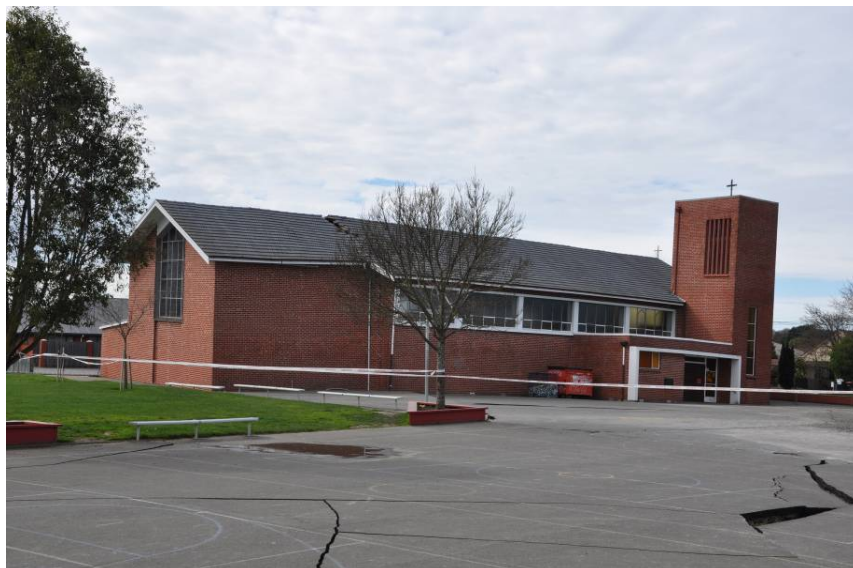
A historically significant feature in the neighbourhood of Dallington is the St. Paul's church and surrounding school (Figure 5.28; 43.5196°S, 172.6725°E). St. Paul's church was severely damaged due to surrounding ground movement, which was precipitated by extensive liquefaction within the general area shown in Figure 5.28. Most significantly the structure suffered through building separation due to ground extension and vertical offset subtending north-south approximately one-third of the length along the west end (orange separation location denoted in Figure 5.29). This resulted in structural separation of the building into two distinct structures. The West end of the building rotated 2 degrees south and 4 degrees west (Figures 5.30-5.33), resulting in 46 cm of settlement of the south-west corner (estimated with reference to prior ground elevation). No significant lateral translation of the building was measured at its perimeter rather structural movement was confined to rotation and settlement as described in Figure 5.29. This relatively heavy single storey structure was constructed of running bond brick perimeter walls, with a timber (truss) roof. Wall heights were approximately 8m at the perimeter of the sloping roof and 5.5m at flat portions. An approximately 12m tall tower is articulated at the southeast corner of the structure (Figure 5.33b). The ridgeline extends across the longitudinal

Figure 5.30. St. Paul's church in Dallington area - overall view of building looking north-east (1345 hrs on 12 September 2010)

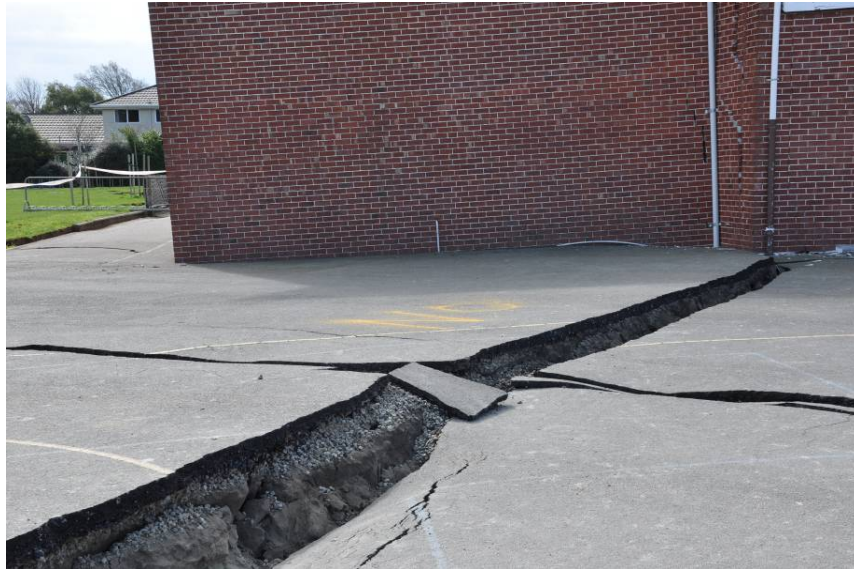
Figure 5.31. St. Paul's church in Dallington area - view looking north at ground failure, which continued through building (1400 hrs on 12 September 2010)
